**RE: Camp FIMFO Catskill
SUN NG KITTATINNY RV LLC
3854 State Route 97
Barryville, NY**

SUBJECT: Kittatinny Campgrounds
Existing Pedestrian Bridge

PURPOSE: Visually inspect existing pedestrian bridge to determine its condition and establish load ratings.

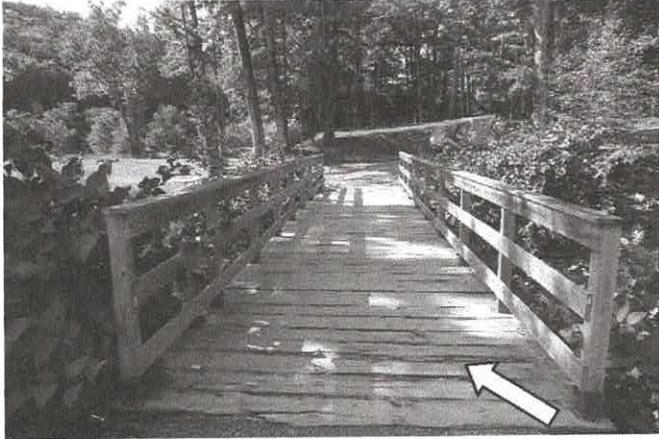
PHOTO #1 –

Deteriorated timber deck on north end of bridge

Three-rail pedestrian bridge rail system

1. In general, the existing pedestrian bridge cannot be load rated based on the deteriorated condition of the existing timber deck. Therefore we recommend removing all existing timber decking and replace with minimum PT 4x8 decking, to span seven feet (7'-0") between existing steel fascia beams.

We recommend replacing the existing bridge rail system with an OSHA compliant rail system.

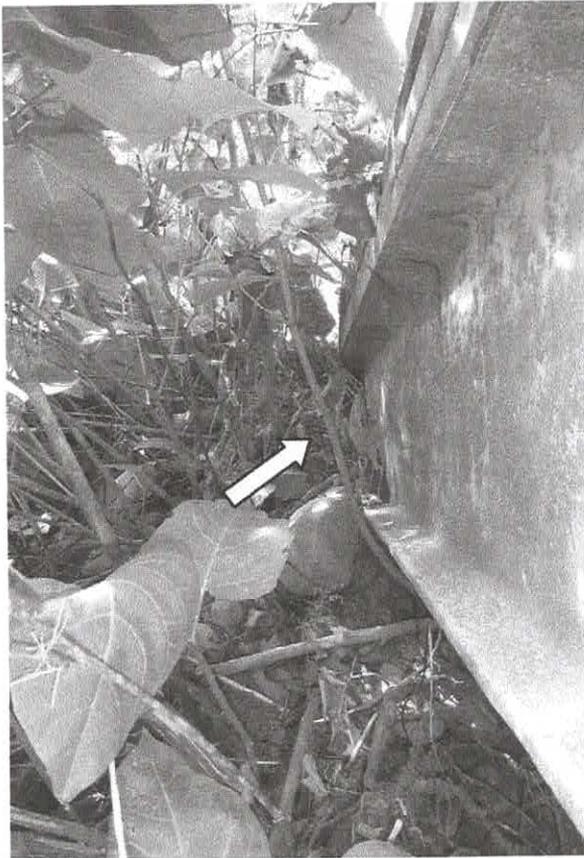
PHOTO #2 – Steel beam embedded in earth embankment

Rust prevalent on steel beam surface.

There is surface rusting visible on the steel fascia beams but it is not significant and does not reduce the load carrying capacity of the structure.

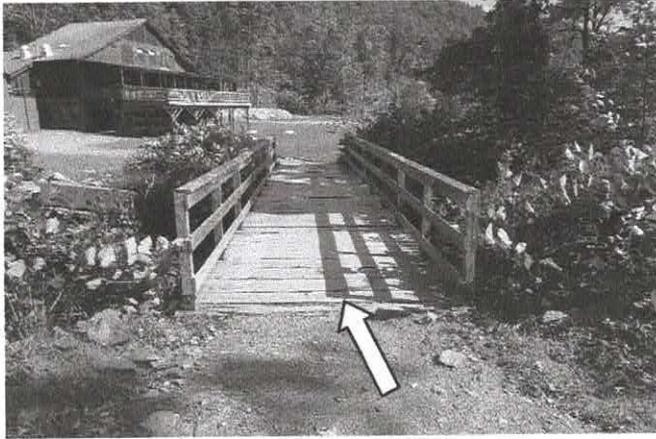
PHOTO #3 –

Deteriorated timber deck on south end of bridge

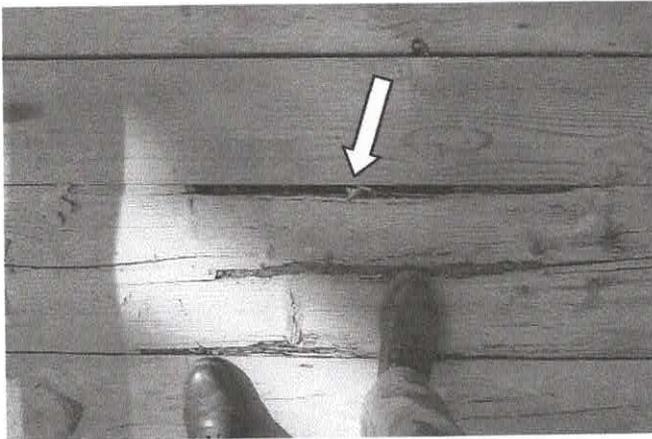
PHOTO #4 –

Deteriorated timber deck above the first transverse steel beam on the north end of bridge

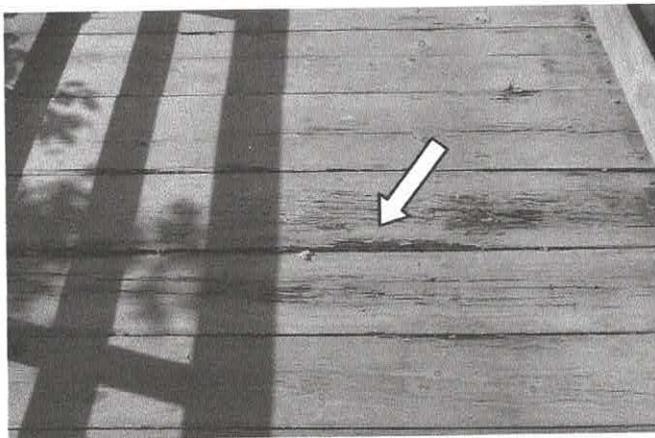
PHOTO #5 –

Deteriorated timber deck above the first transverse steel beam on the south end of bridge

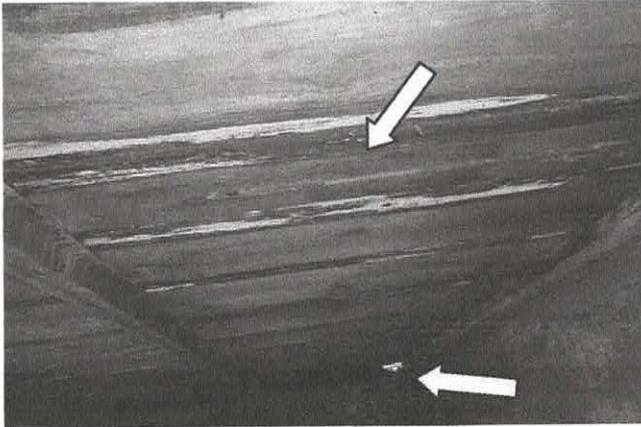
PHOTO #6 –

Underside of deteriorated timber deck between 1st & 2nd channel on south end of bridge

No end diaphragm present between end of bridge and adjacent finished grade as seen by the light penetrating through

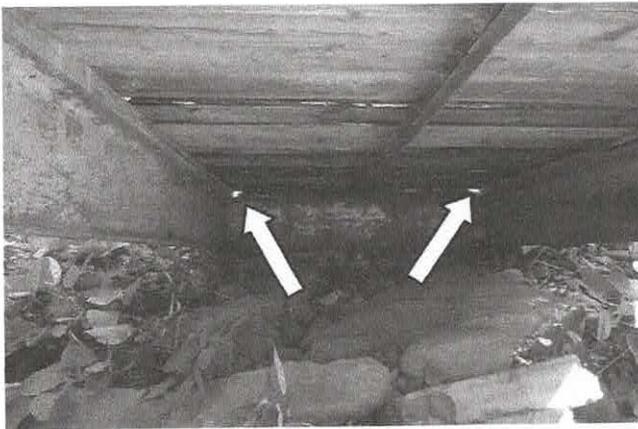
PHOTO #7 – Underside of deteriorated timber deck between 1st & 2nd channel on north end of bridge

No end diaphragm present between end of bridge and adjacent finished grade as seen by the light penetrating through

Beams embedded in soil

Significant rusting on all steel framing

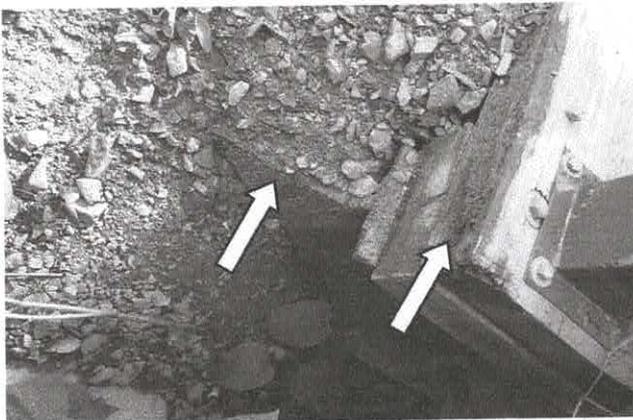
PHOTO #8 – Beams embedded in soil on northwest end of bridge

No end diaphragm separating bridge structure from soil

Deteriorated deck
